HELMET IMPACT TESTS: ANR EARCUP STRUCTURAL INTEGRITY AND THE EFFECT OF THE ANR EARCUP SYSTEM ON HELMET ENERGY ATTENUATION

INTERIM REPORT FOR THE PERIOD SEPTEMBER 1992 - DECEMBER 1992

AL/CF-SR-1993-0006

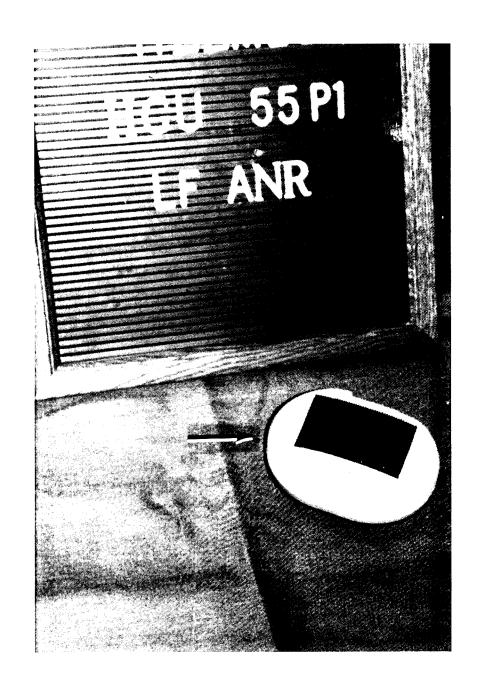
FIGURE 23. ANR EARCUP DAMAGE AFTER TEST #5

The structural integrity of the ANR earcup system can be demonstrated in Figures 22 through 26. The figures document that in the HGU-55/P helmet, the earcups show little deformation after impact other than slight cracks on the back of each earcup shell as shown by Figures 22 and 23. Figures 24 and 26 show that in the HGU-53/P helmet, the ANR shell received major structural damage after impact. Figure 25 also shows where the gel filled earpad ruptured after impact. The standard earcups in either the 55/P or 53/P helmet did not sustain structural damage (shell or earpad) after impact.

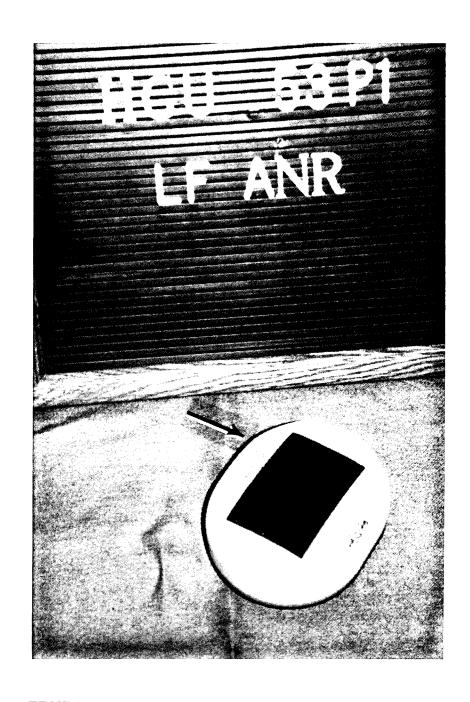
FIGURE 25. ANR EARCUP DAMAGE AFTER TEST #7

Tests were conducted on a helmet drop facility to compare standard earcups and the ANR earcups in two areas: effect on helmet impact energy attenuation, and earcup structural integrity. The earcups performed equally well in their ability to affect the energy attenuation properties of the helmet system when subjected to an impact of 35 ft-lbs. The standard earcup's structural integrity was much better than the ANR earcups as the standard earcups displayed no damage during impact, but each ANR earcup sustained some damage to its outer shell during impact. A possible explanation for this could be that the standard earcup has a low density foam cushion that forms to the ear, while the ANR earcup has a high density gel cushion that would not absorb the short-time duration energy from the impact as well as the low density foam. The results would be that the energy transmitted through the helmet shell during impact would be partially absorbed by the outer shell of the ANR earcup instead of the cushion, resulting in structural failure of the earcup shell.

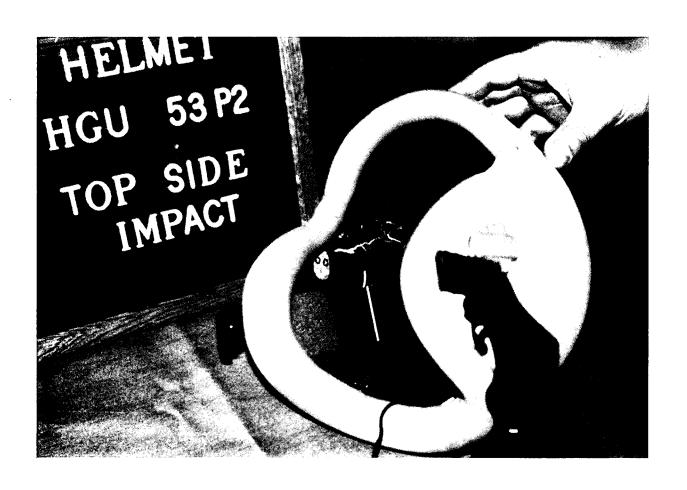
FIGURE 28. DAMAGE TO LINER OF 53/P HELMET AFTER 50 FT-LB IMPACT ENERGY TEST

Figure 27 shows the point of impact for the final test conducted at the 50 ft-lb impact energy level. The HGU-53/P helmet showed no visible damage to the outer shell, but the inner styrofoam liner beneath the point of impact was damaged as shown in Figure 28. This is the function of the liner (energy absorption) and was considered a positive test result.
